DOE/NV--1284

Post-Closure Inspection and
Monitoring Report for Corrective
Action Unit 110: Area 3 WMD
U-3ax/bl Crater, Nevada Test Site,
Nevada

For the Period July 2007–June 2008

August 2008

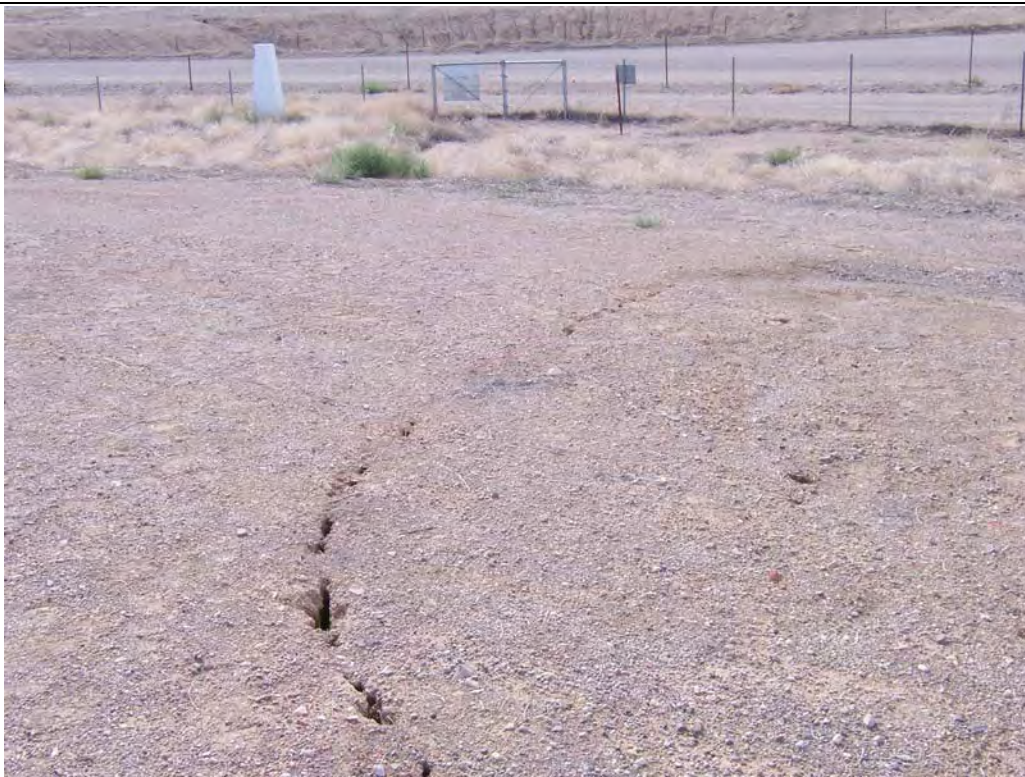
- Minor evidence of small mammal burrowing was observed on the cover; however, the burrows were not large enough to warrant the need for corrective action.
- Settling and cracks that exceeded the compliance criterion were observed around two previously repaired areas on the south and east edges of the cover. The cracks required repair within 60 days.
- The condition of UR warning signs, fencing, TDR stations, SMs, and cover vegetation was good.

9. View of crack on the south edge of the Area 3 WMD U-3ax/bl cover.

- Perform repairs on the cracks on the south and east edges of the cover within 60 days.
- Continue inspections as scheduled.

During the September 27, 2007, inspection, two areas of settling and cracks that exceeded the settling compliance criterion were observed on the south and east edges of the cover. The areas were repaired on October 22–24, 2007. A remote vibratory compactor was used to compact the cracks in the cover. The areas were backfilled with clean, native soil using wheelbarrows and shovels, and then compacted using the compactor. Field notes for this repair are included in Appendix A.

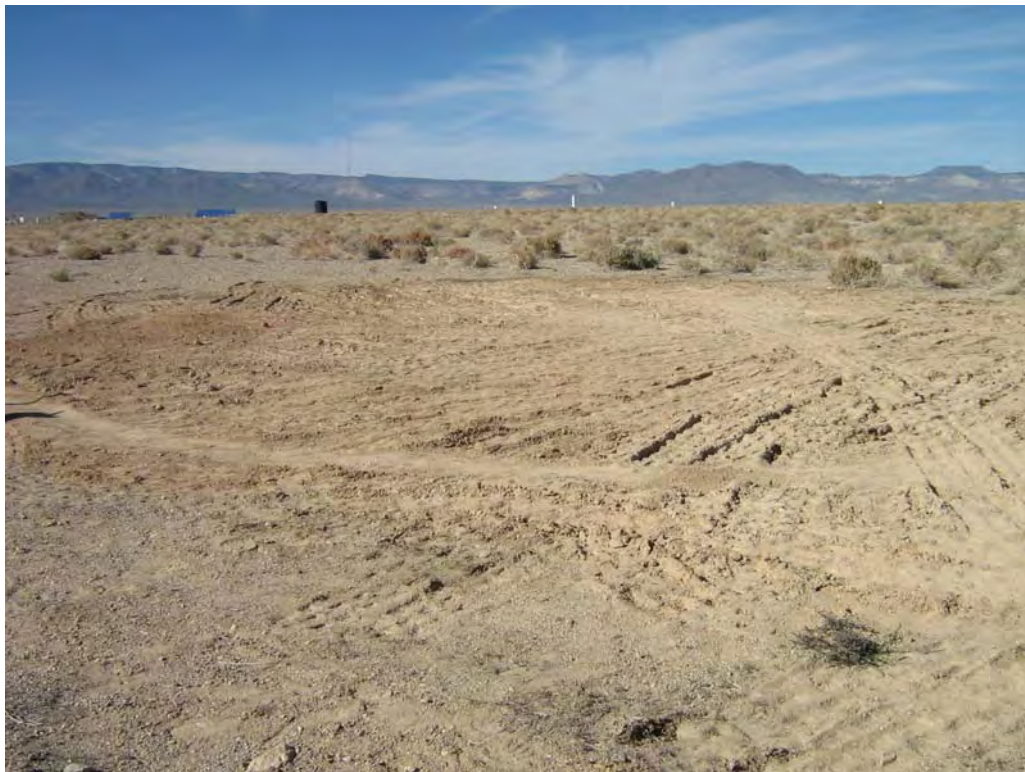
10. View of the south edge of the Area 3 WMD U-3ax/bl cover, after repairs.

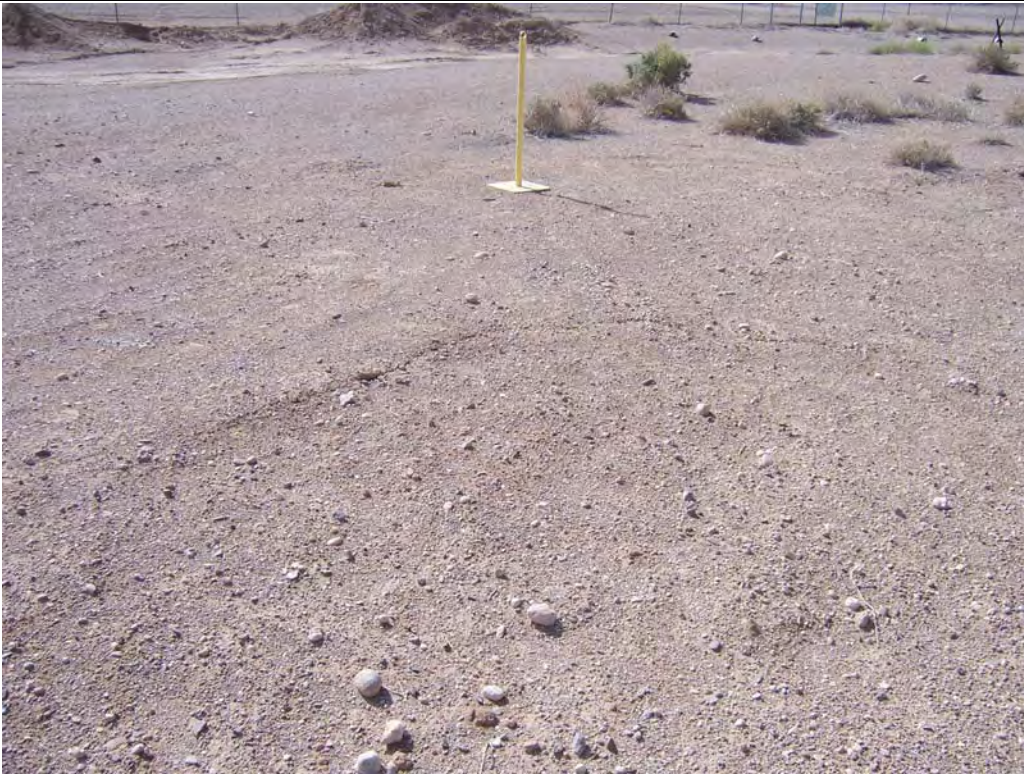
11. View of crack on the east edge of the Area 3 WMD U-3ax/bl cover.

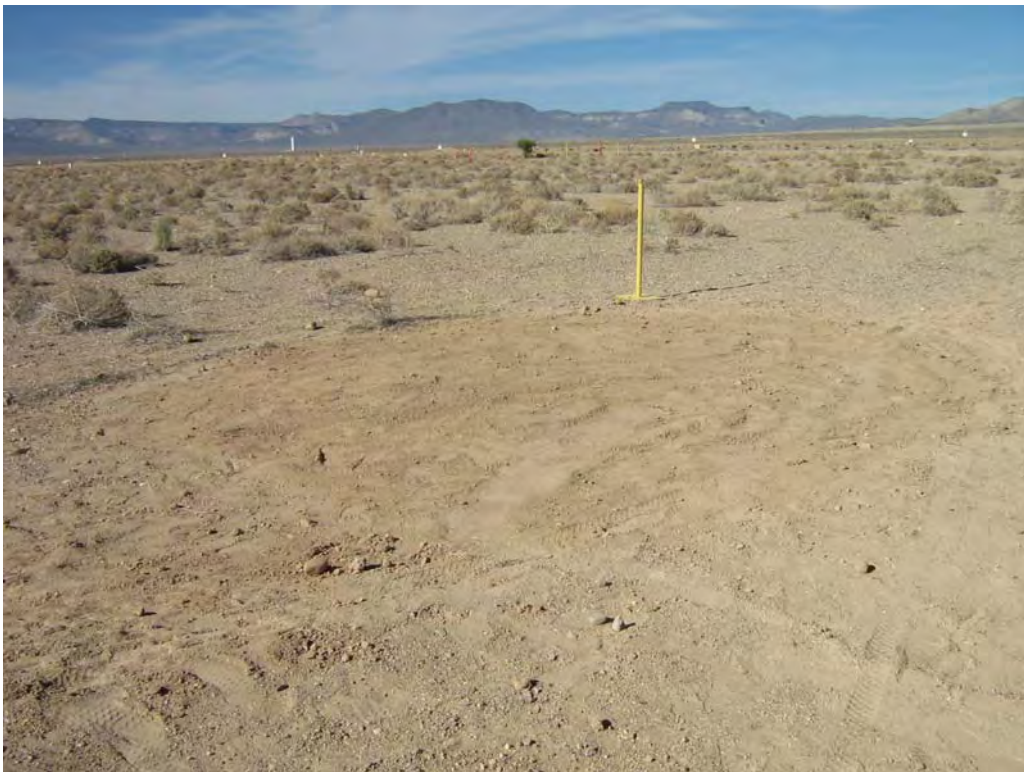
12. View of the east edge of the Area 3 WMD U-3ax/bl cover, after repairs.

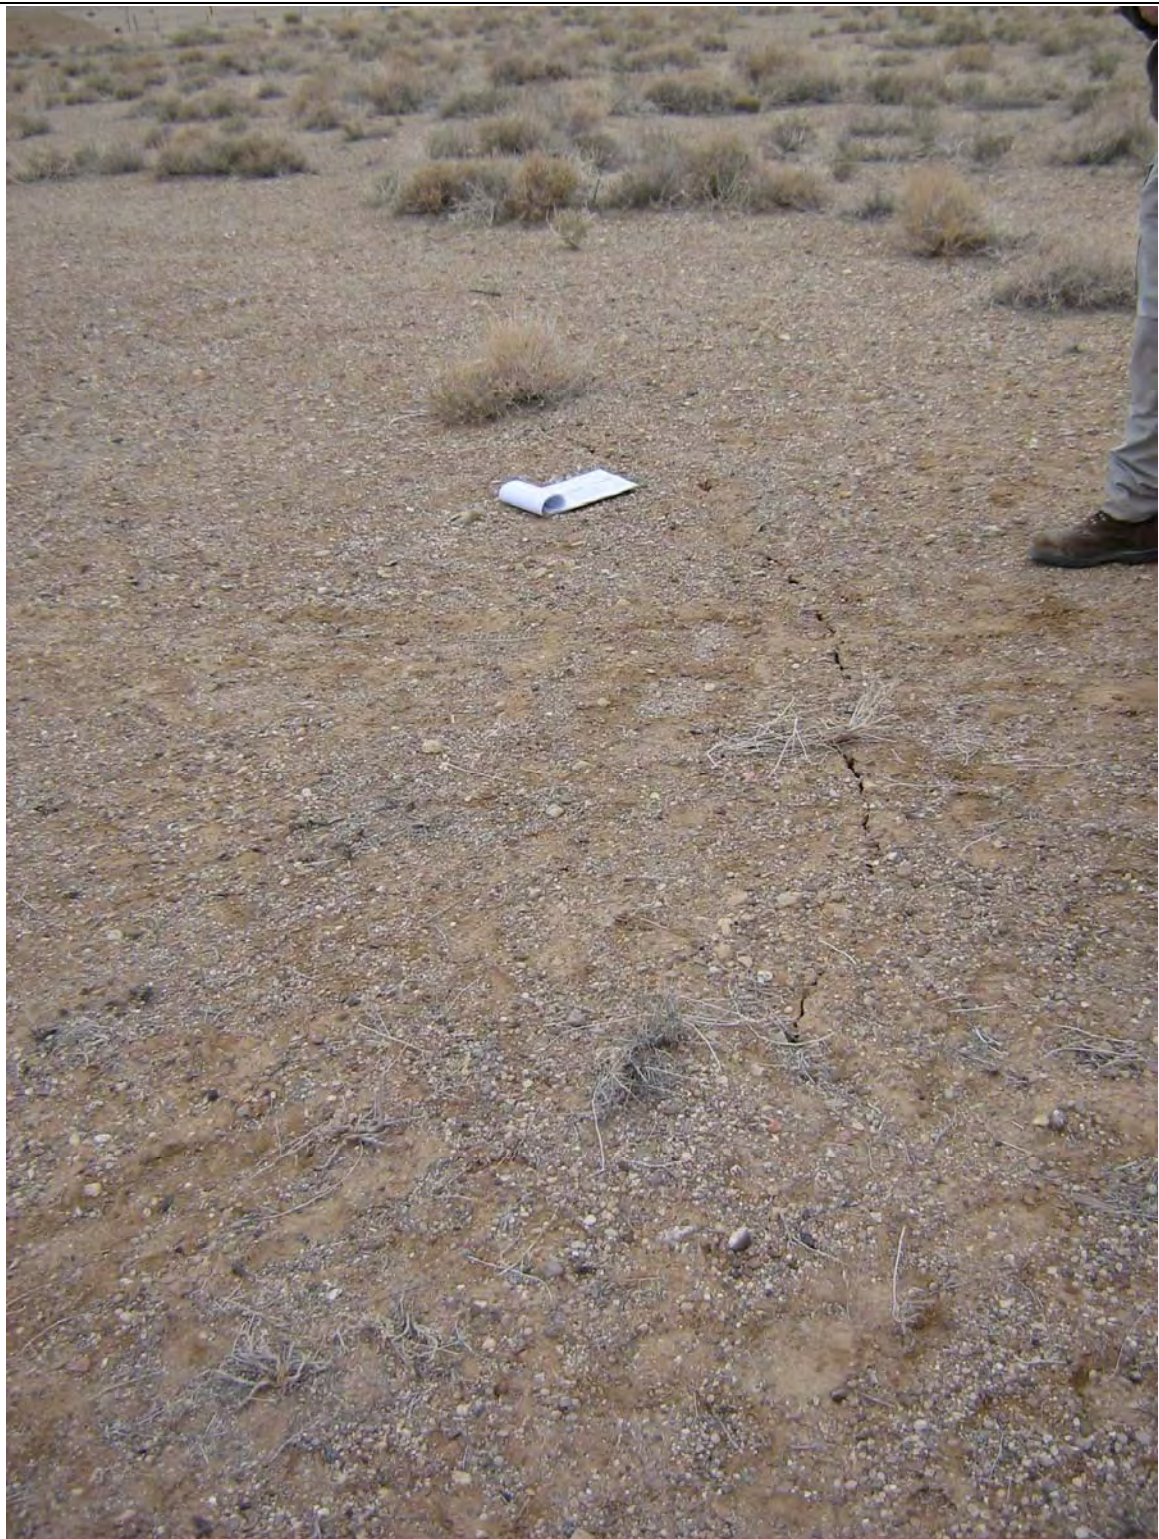
- The cracks observed during the September inspection had been repaired on October 22–24, 2007, and were in good condition with no indication of further cracking or settling.
- A new depression and cracks were observed on the east side of the cover that required repair within 60 days.
- Small mammal burrows were observed on the cover that did not require corrective action.
- The condition of UR warning signs, fencing, TDR stations, SMs, and cover vegetation was good.

17. View of crack on the south edge of the Area 3 WMD U-3ax/bl cover.

- Perform repairs on the new cracks on the east side of the cover within 60 days.
- Continue inspections as scheduled.

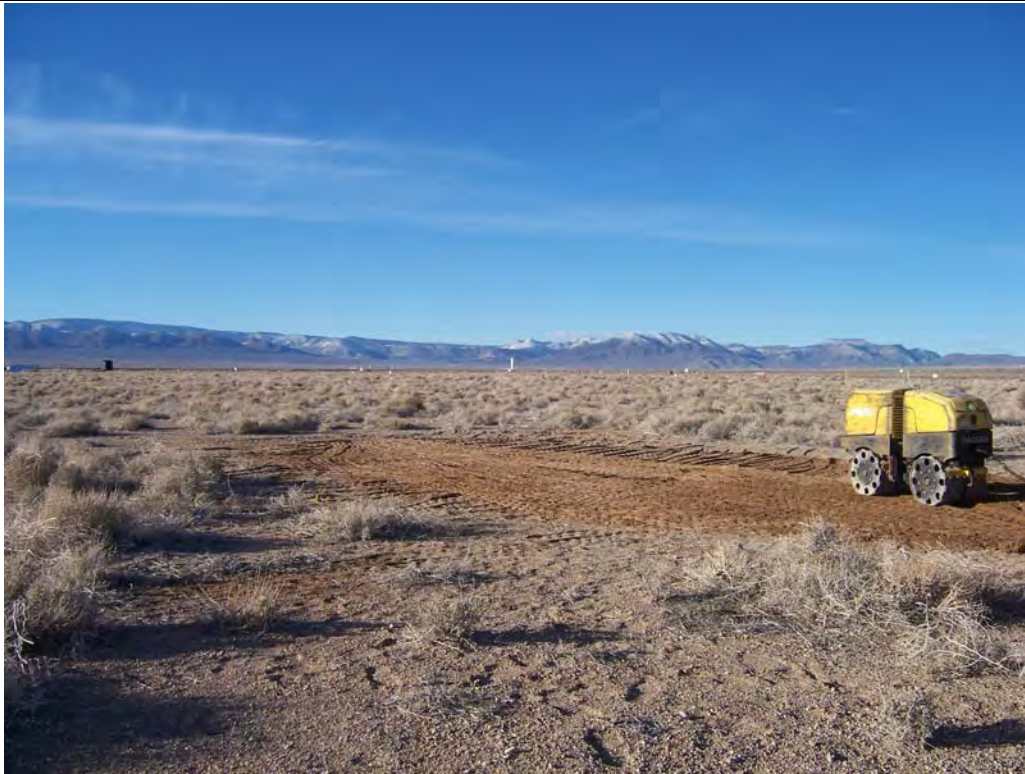
18. View of the south edge of the Area 3 WMD U-3ax/bl cover, during repairs.

- The depression and cracks observed on the east side of the cover during the December inspection had been repaired on January 29–30, 2008, and were in good condition with no indication of further cracking or settling.
- No other settling or cracks were observed on the cover.

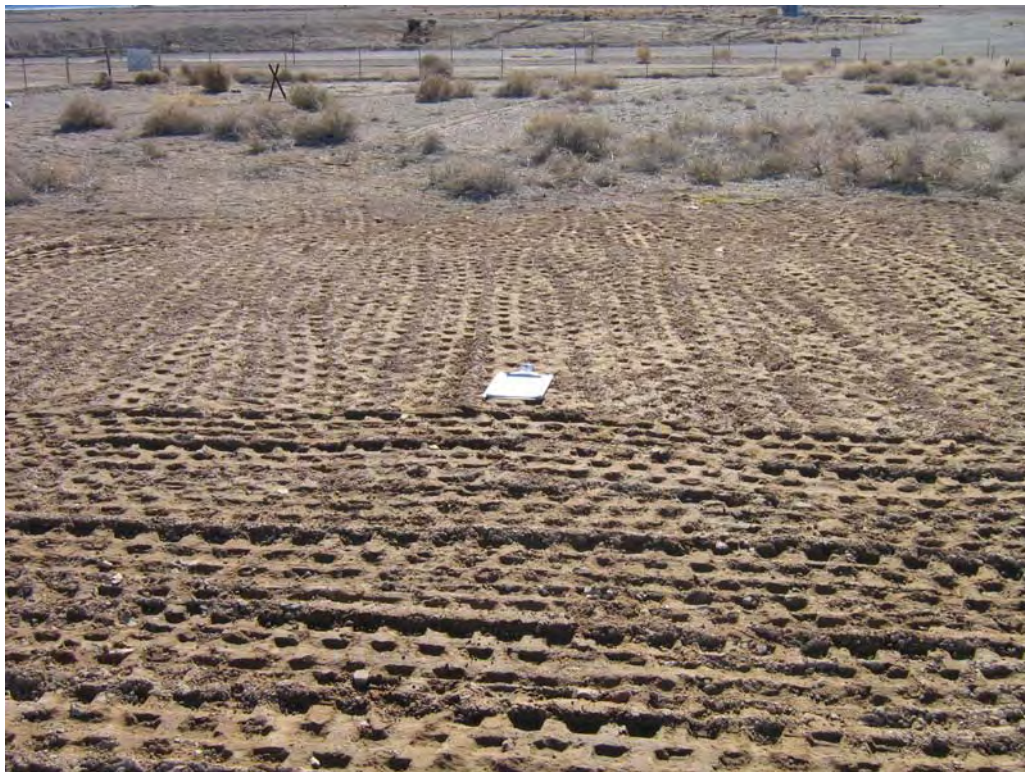
19. View of the south edge of the Area 3 WMD U-3ax/bl cover, after repairs.
